BROOMALLS DAM

(NDS I.D. NO. 7 PA 00349,
DER I.D. NO. 23-9)

PHASE I INSPECTION REPORT
NATIONAL DAM INSPECTION PROGRAM

11 March 1980

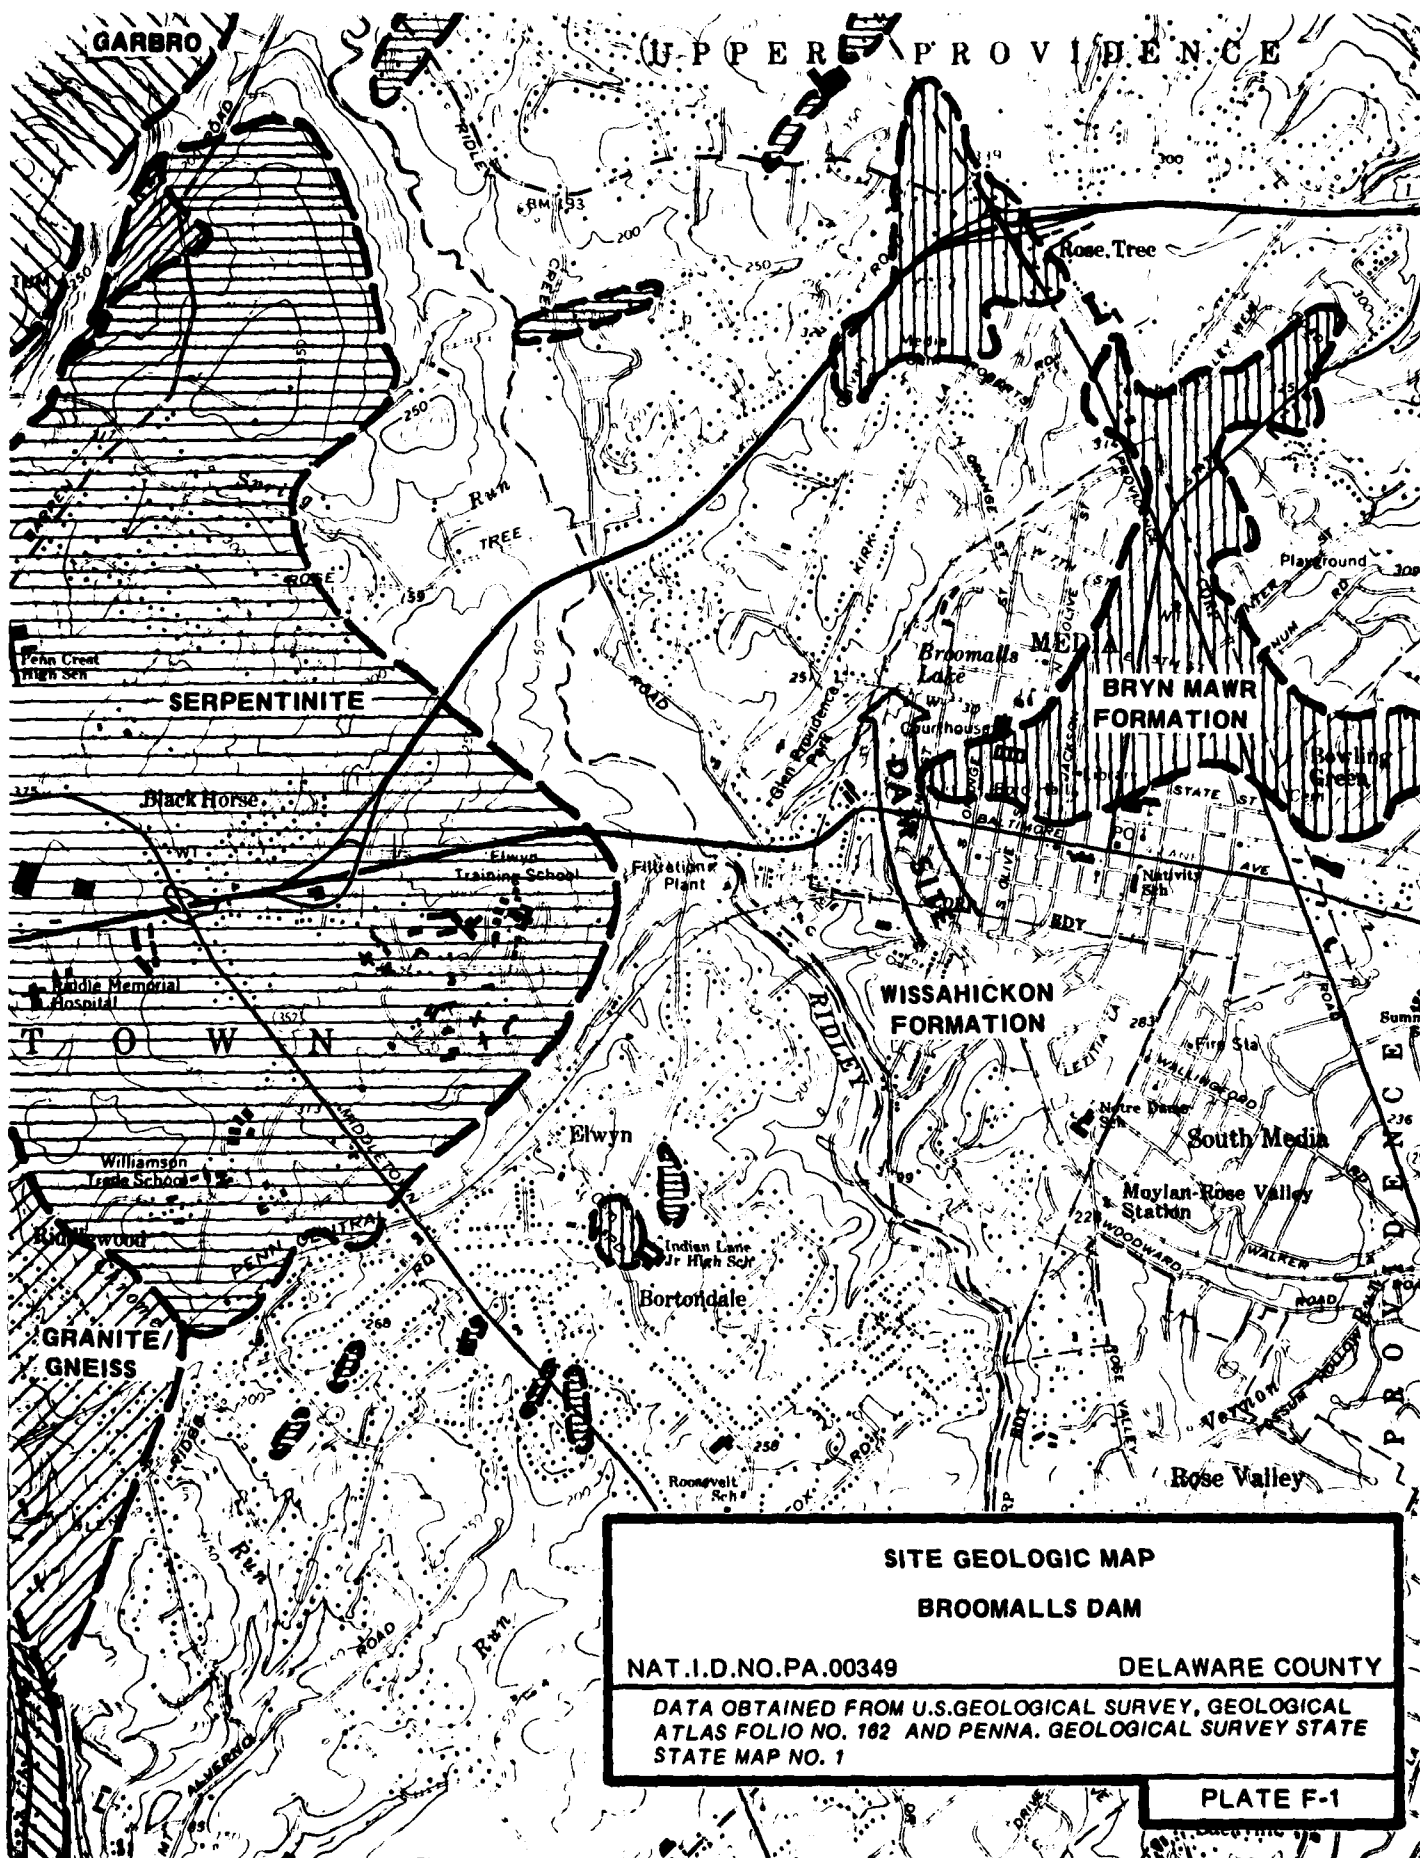
SITE GEOLOGY
BROOMALLS LAKE DAM

An exposure of schist in the parking area next to the clubhouse has foliation, which strikes to the northeast (oblique to dam axis) and dips at a high angle to the southeast (downstream direction). This rock attitude could in part contribute to the formation of the seepage area observed along the toe of the right half of the dam.
